# Failure Analysis of Segmented Loop Diamond Wire:

## Fracture Causes and Mechanisms

Date: March 2026 | Classification: Technical Analysis

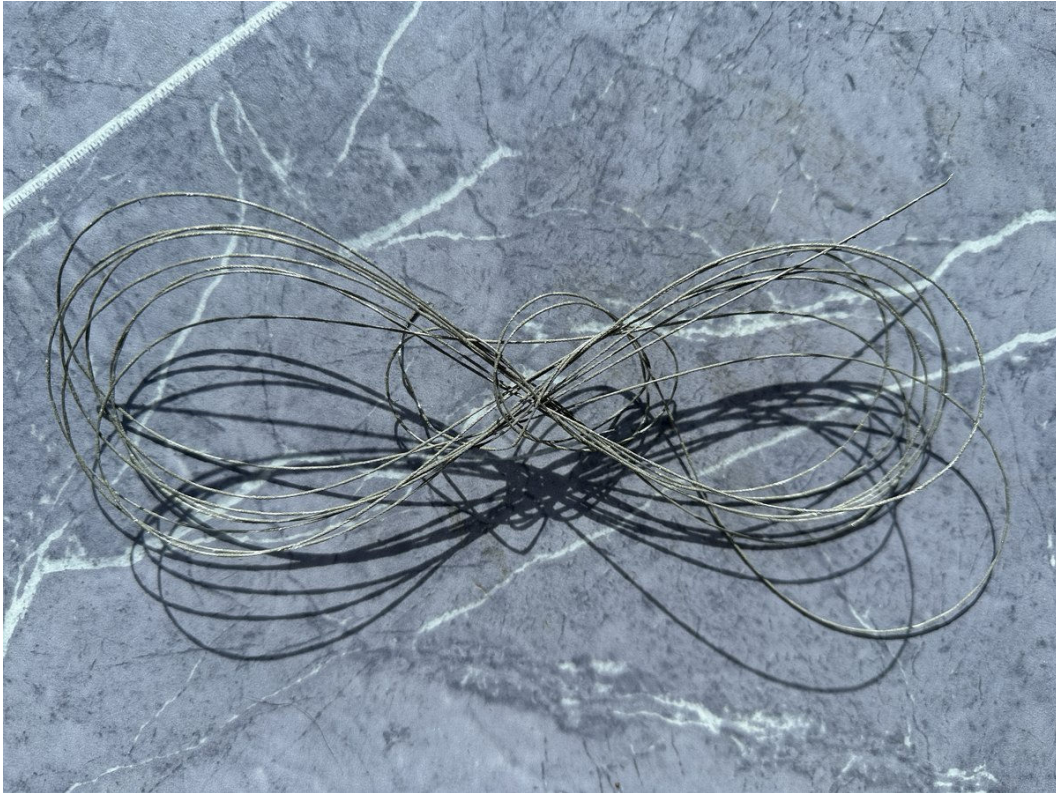
The fractured specimens have entirely lost their original loop geometry. The wire segments are disordered and entangled, forming a characteristic figure-eight pile (Fig. 2). This pattern indicates that fracture did not occur instantaneously at a single cross-section; rather, the wire lost structural integrity progressively, allowing the released elastic energy to redistribute and coil the wire into a tangled mass.

*Fig. 2 — Macroscopic overview of the failed wire assembly. The complete loss of loop geometry and the characteristic tangled configuration are indicative of a progressive, energy-releasing fracture event.*

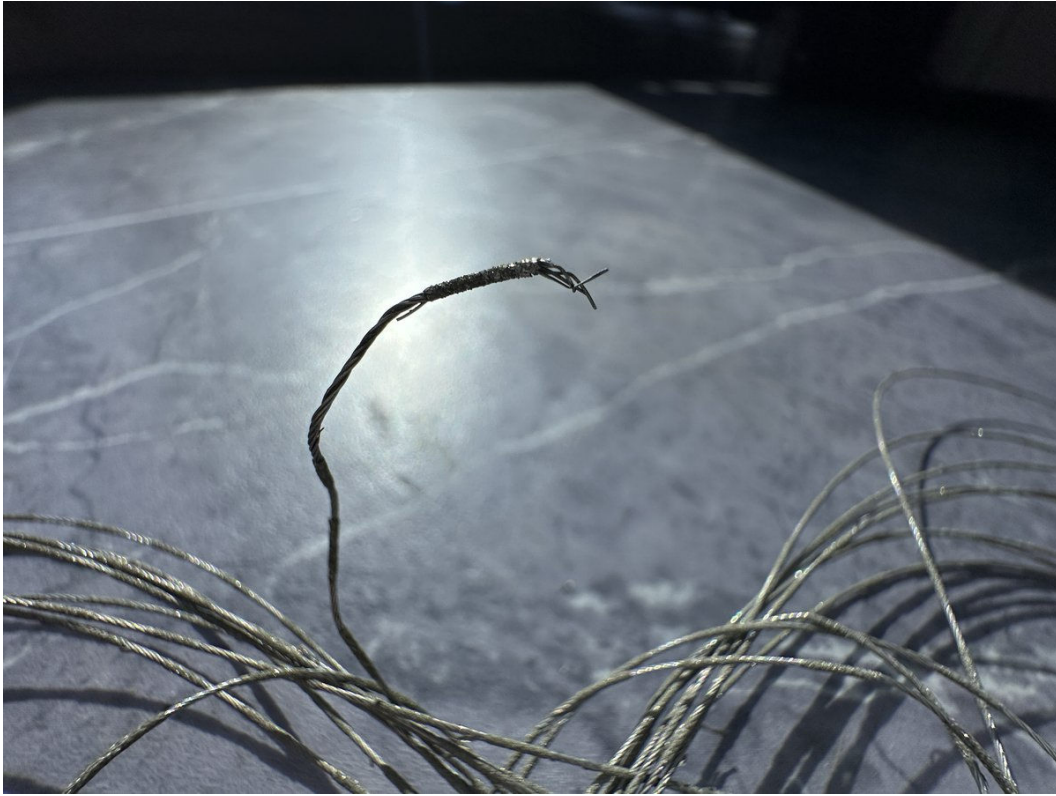
Close inspection of fracture ends reveals that individual wire strands are spread apart and bent into hook or curl shapes at the terminus (Fig. 3). This morphology is fundamentally inconsistent with a single-event static overload fracture, which would produce a flush, planar break across all strands simultaneously. Instead, the progressive strand separation and curvature are classical indicators of fatigue fracture, in which individual strands fail sequentially as fatigue cracks propagate independently through each sub-wire.

*Fig. 3 — Fracture-end detail showing individual strands splayed apart and curled into hook configurations. This progressive strand-by-strand separation is diagnostic of fatigue failure rather than brittle or overload fracture.*

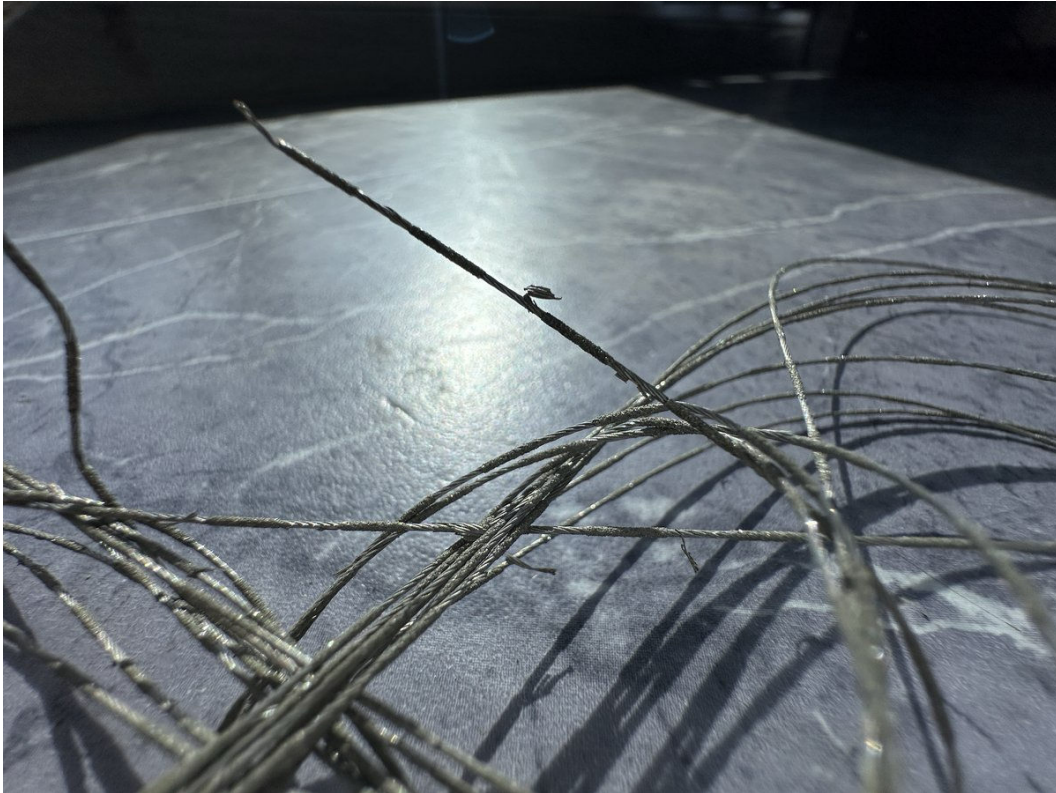
A distinct nodular protrusion was identified on one of the fractured wire segments (Fig. 4). This feature is consistent with the weld joint used to close the diamond wire into a continuous loop. The joint region constitutes a geometric discontinuity that concentrates stress during cyclic loading, making it the highest-risk initiation site for fatigue cracking. In addition, the metallurgical properties of the heat-affected zone adjacent to the weld are generally inferior to the base wire, further reducing local fatigue resistance.

Fig. 4 — A nodular protrusion (arrowed) consistent with the loop weld joint. Geometric and metallurgical discontinuities at this location promote preferential fatigue crack initiation.

| <b>5</b> | <b>Weld Joint Stress Concentration and Final Fracture</b><br>The weld joint (Fig. 4) represents a geometric and metallurgical stress concentration. In the context of already-degraded wire, this location was most susceptible to fatigue crack initiation, likely serving as the final fracture trigger that caused complete loop failure. |

- **Improve weld joint quality** — Audit the weld joint for geometric conformity and hardness. Consider post-weld heat treatment or mechanical dressing to reduce the stress concentration factor at the joint.

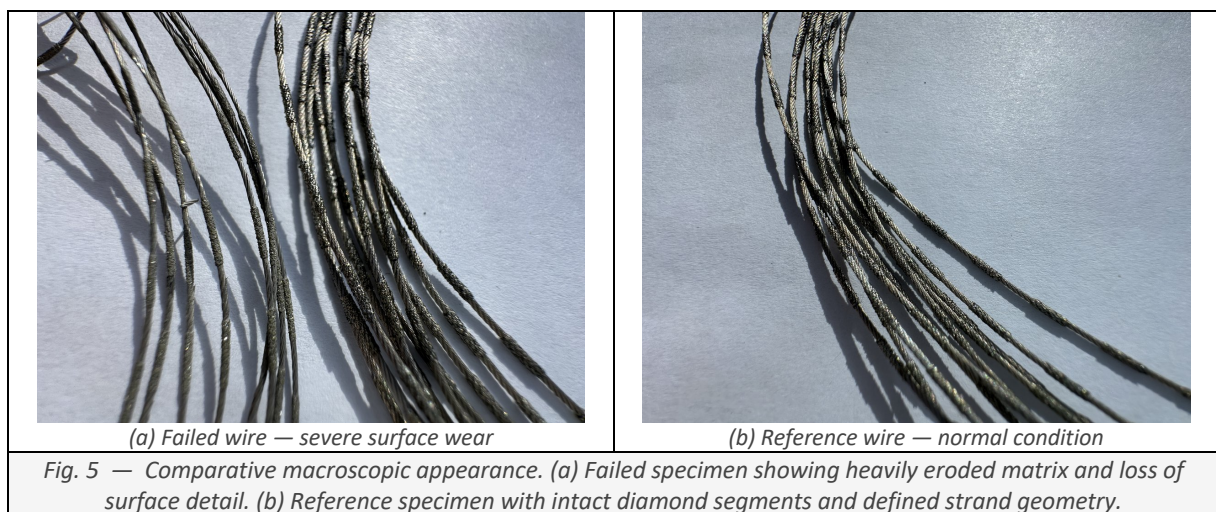
A side-by-side comparison of the failed wire and the reference specimen reveals dramatically different surface textures (Fig. 5). The failed wire exhibits a dull, rough surface with poorly defined strand geometry, indicating advanced matrix erosion. In contrast, the reference wire retains a bright, well-defined helical strand pattern. This differential wear confirms that the failed wire had been operated well beyond its effective service life before fracture occurred.

- **Implement condition-based wire retirement** — Establish surface inspection intervals; retire wire at the first signs of significant matrix blackening or diamond grit depletion, before the onset of fatigue cracking in the steel core.

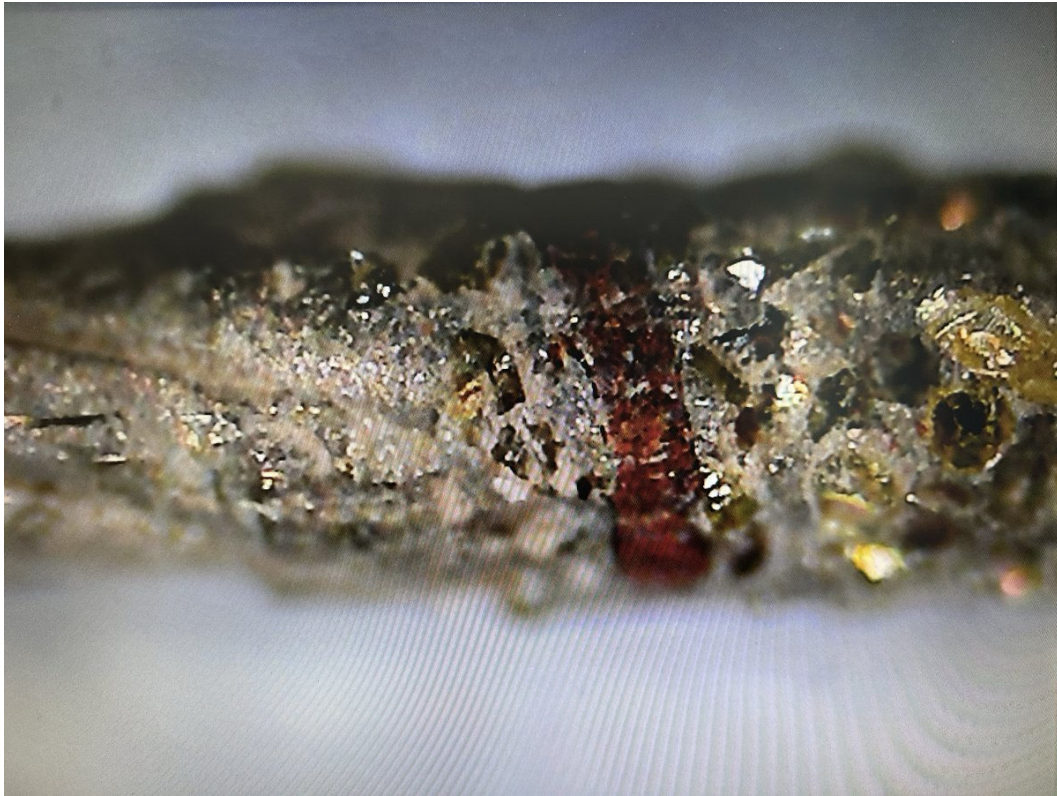
Optical microscopy at the fracture zone reveals reddish-brown deposits concentrated within the matrix and at grain boundaries (Fig. 6). These deposits are characteristic of iron oxide ( $\text{Fe}_2\text{O}_3/\text{Fe}_3\text{O}_4$ ) corrosion products resulting from oxidation of the steel core and metallic matrix. Corrosion damage reduces the effective load-bearing cross-section of the steel core and introduces stress-corrosion cracking susceptibility, both of which significantly accelerate fatigue crack propagation.

Fig. 6 — Optical micrograph of the fracture zone showing reddish-brown iron oxide deposits (indicated by arrow) within the damaged matrix, consistent with corrosion-assisted degradation of the steel core.

| <b>3</b> | <b>Corrosion-Assisted Crack Initiation</b><br>Moisture ingress through the degraded matrix promoted oxidation of the steel core. Corrosion pits and oxide-induced surface notches acted as preferential fatigue crack initiation sites, reducing the endurance limit of the wire significantly. |

- **Prevent corrosion** — Store unused wire in a dry, sealed environment. Use a corrosion-inhibiting coolant formulation during operation to retard oxidation of the steel core.

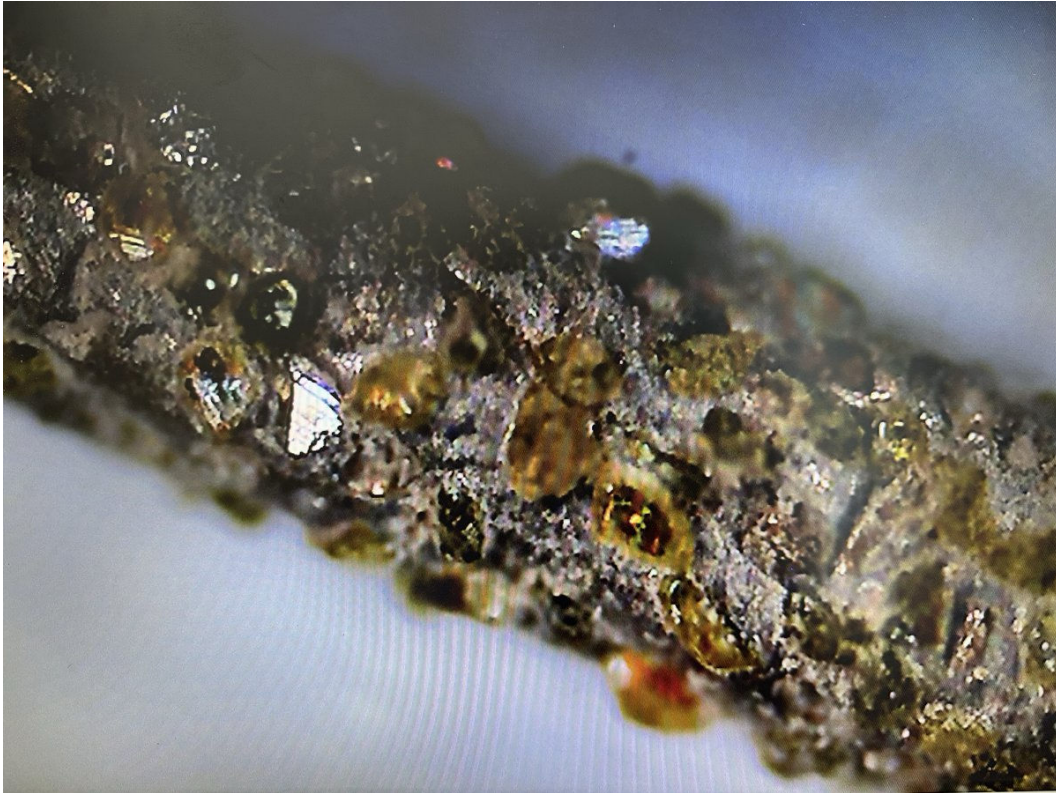
Examination of the matrix surface in a mid-body region of the failed wire reveals extensive diamond grit loss (Fig. 7). Numerous circular and elliptical voids are present where diamond abrasives have been detached from the matrix. The surrounding matrix material appears thermally darkened (brown to black), consistent with oxidative heating above  $\sim 400^\circ\text{C}$ . This thermal discoloration indicates that insufficient coolant flow or excessive cutting speed led to localized overheating, which softens the metallic matrix and dramatically weakens the mechanical grip on diamond grains. Once grit is lost, the remaining matrix is rapidly ground away, exposing the bare steel core to direct abrasive loading.

*Fig. 7 — Optical micrograph showing the matrix of the failed wire with extensive diamond pullout voids (dark circular pockets) and thermally darkened matrix material, indicative of localized overheating and accelerated abrasive wear.*

| <b>1</b> | <b>Advanced Matrix Wear and Thermal Overloading</b><br>Aggressive cutting parameters (excessive wire speed or feed rate) combined with inadequate coolant delivery generated localized thermal spikes. Matrix softening above ~400 °C weakened the mechanical retention of diamond abrasives. |
| <b>2</b> | <b>Diamond Grit Loss and Exposure of Steel Core</b><br>Progressive diamond pullout stripped the wire of its abrasive capability, forcing increased applied load to maintain cutting rate. The bare steel core was thereby exposed to direct abrasive and compressive forces, dramatically increasing the bending stress amplitude experienced by each strand. |

- **Optimize cutting parameters** — Reduce wire speed and/or workpiece feed rate to keep the cutting zone temperature below the matrix softening threshold. Verify that coolant flow is directed precisely at the cut interface.

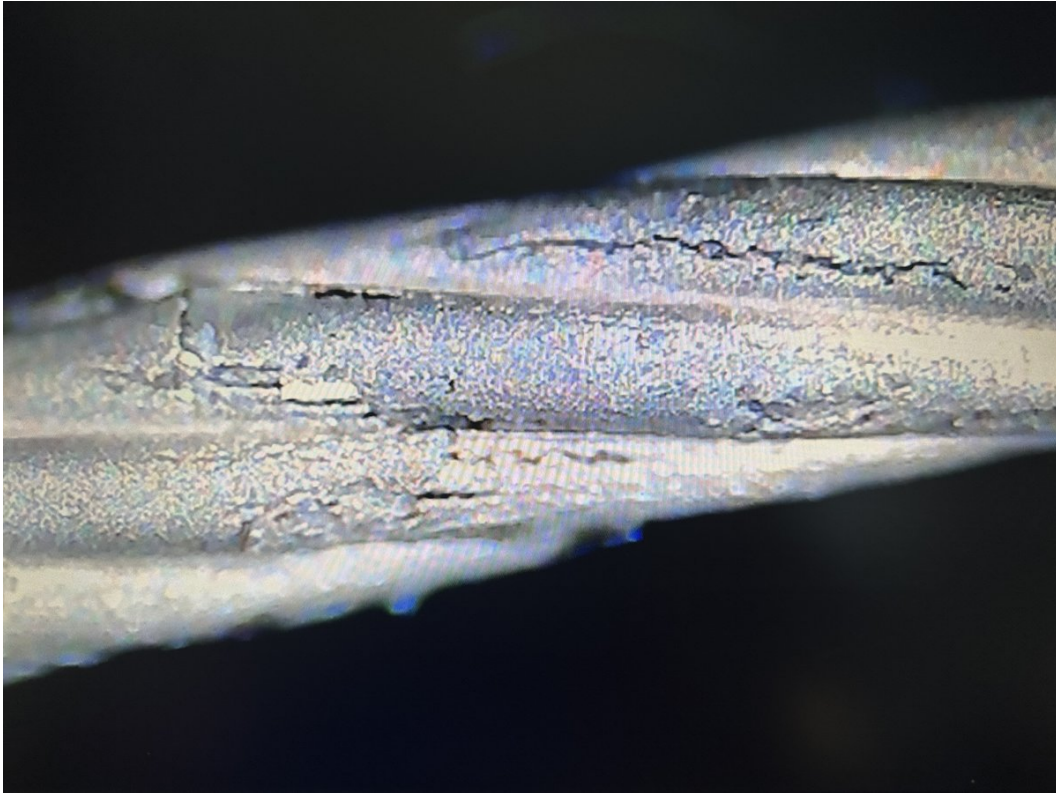
The most critical microscopic evidence is found on the exposed steel core strands near the fracture zone (Fig. 9). Multiple continuous cracks oriented parallel to the wire axis are clearly visible on strand surfaces. These axial cracks are the hallmark of rotary bending fatigue: as the wire repeatedly bends around guide pulleys, alternating tensile and compressive stresses are generated on the outer fibers of each strand. Fatigue damage initiates at surface stress risers (corrosion pits, micro-notches at matrix-core interfaces) and propagates axially along the strand until the remaining ligament is insufficient to sustain the applied load, resulting in sudden final fracture.

*Fig. 9 — Optical micrograph of the exposed steel core, showing multiple axially oriented fatigue cracks propagating along the strand surface. This evidence constitutes the primary proof of rotary bending fatigue as the dominant failure mechanism.*

| <b>4</b> | <b>Rotary Bending Fatigue — Primary Failure Mechanism</b><br>The steel core underwent millions of bending cycles as the loop circulated over guide pulleys. Fatigue cracks nucleated at surface defects, propagated axially along individual strands (Fig. 9), and caused progressive strand failure in a sequential manner (Figs. 10, 11), ultimately reducing load-bearing capacity to zero. |

- **Review pulley geometry** — Verify that guide pulley diameters are consistent with the wire's minimum bend radius specification. Excessively small pulleys increase the bending stress amplitude per cycle and dramatically shorten fatigue life.

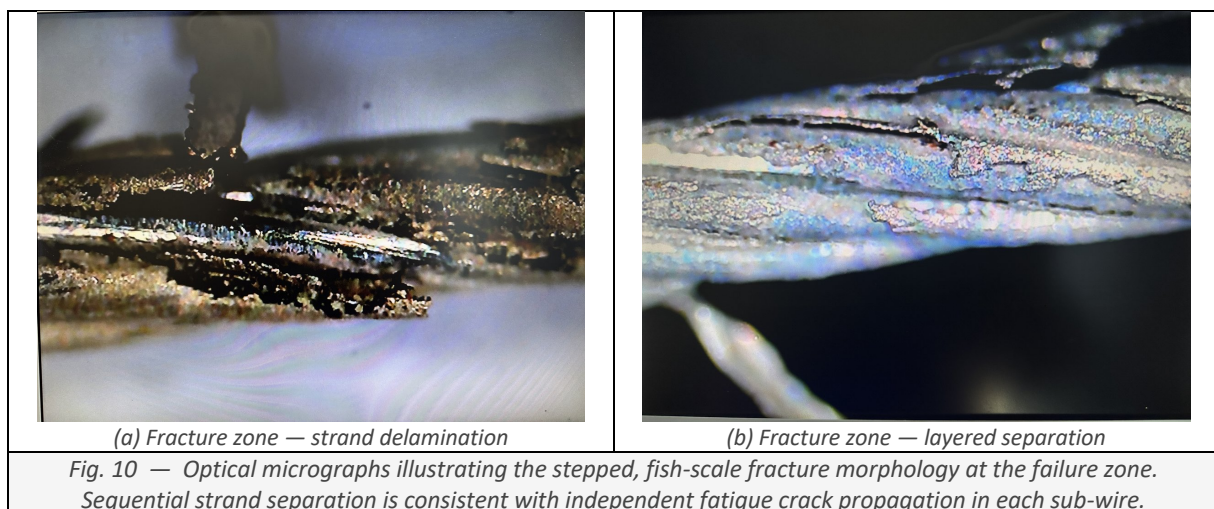
Cross-sectional and oblique views of the fracture zone reveal a distinctive fish-scale layering pattern, with individual strands peeled apart and separated in a stepwise manner (Figs. 10 and 11). This delamination morphology arises when fatigue cracks propagate in each strand independently and at slightly different rates; the final overload fracture then propagates across strands sequentially rather than simultaneously, producing the observed stepped fracture surface. The absence of a flat, featureless fracture plane definitively excludes instantaneous overload or embrittlement as the primary cause.
