# Failure Analysis of Segmented Loop Diamond Wire:

## Fracture Causes and Mechanisms

Date: March 2026 | Classification: Technical Analysis

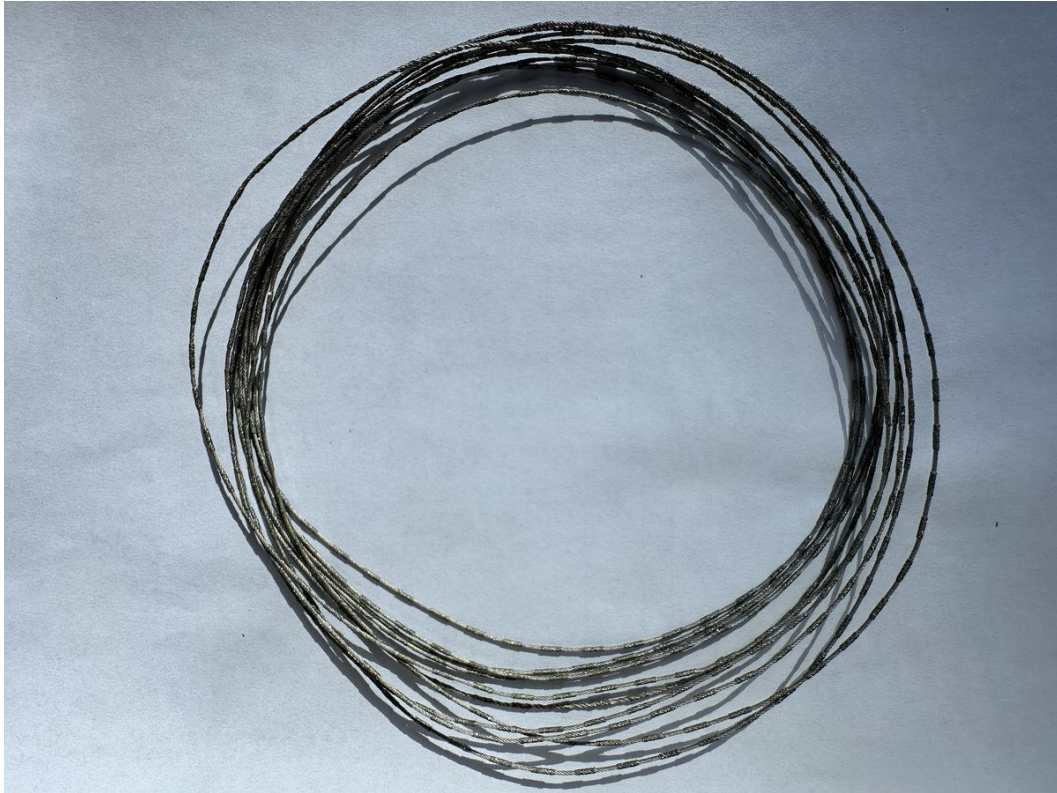
*Fig. 1 — Reference specimen: intact segmented loop diamond wire in its as-received condition, showing the characteristic multi-turn loop geometry.*

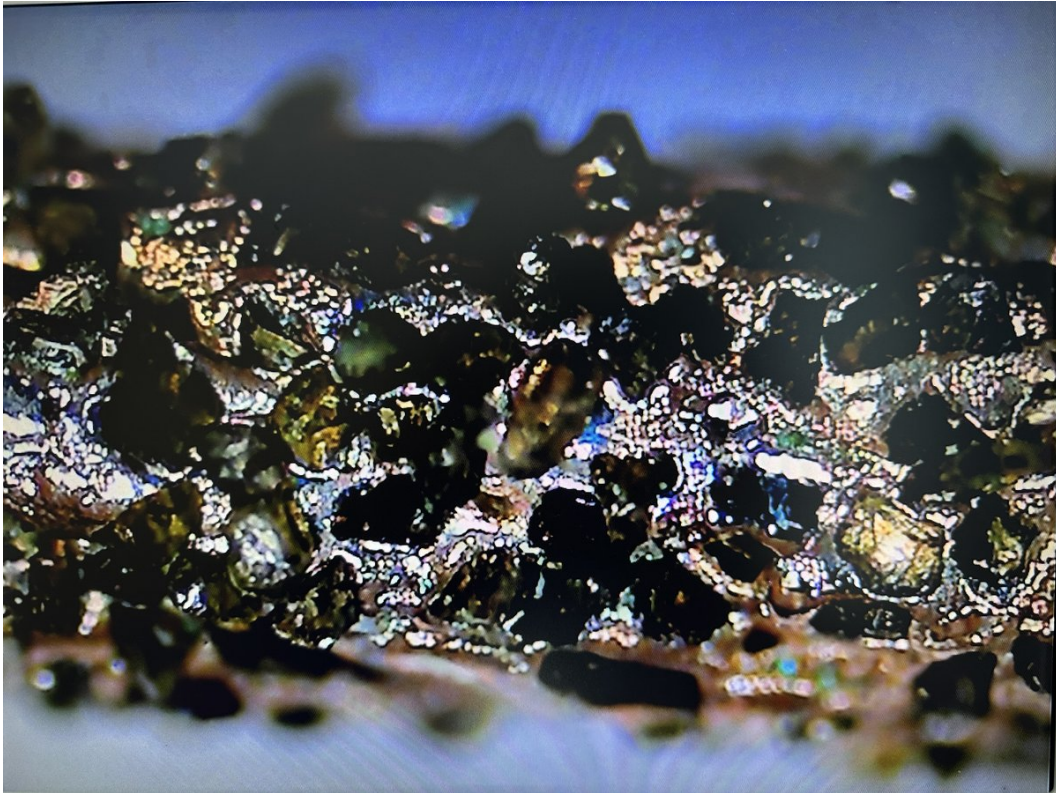
For comparison, a section of wire exhibiting relatively normal wear was examined (Fig. 8). Diamond grains are well-retained, display angular morphology consistent with minimal thermal alteration, and are distributed throughout a dense metallic matrix. The contrast with the failed region (Section 4.2) clearly demonstrates the role of thermal and mechanical overloading in destabilizing the matrix and triggering accelerated grit loss.

*Fig. 8 — Optical micrograph of a reference section showing well-retained diamond grains with intact angular morphology, embedded in a dense metallic matrix. This represents normal, serviceable wire condition.*
